Conflict-stricken Churches

The impact of the conflict on church buildings across Chin state

REPORT BY MYANMAR WITNESS, published January 2024, information accurate as of July 2023

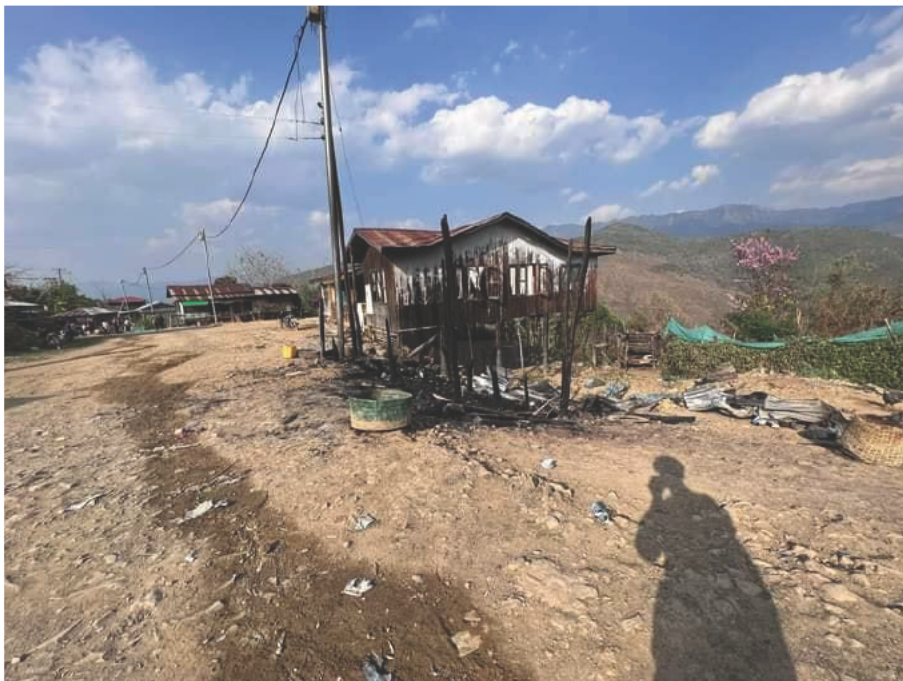
Figure 6: Houses were reportedly destroyed in Khuafo following MAF airstrikes. UGC geolocated by Myanmar Witness shows structural and fire damage to several residential buildings. One building [22.751467, 93.425619] was seemingly reduced to ashes (source: [Khonumthung Burmese](#), warning: graphic link).

UGC [released](#) (warning: graphic link) on the day of the alleged attack and geolocated by Myanmar Witness shows damage to several buildings in the village, including Khuafo Baptist Church. Due to cloud coverage obscuring satellite imagery, it was not possible to verify the date of the alleged airstrike through chronolocation. Additional images have been widely [shared](#) (warning: graphic link) online apparently depicting burial ceremonies for the deceased villagers, whom various outlets have also [named](#). Myanmar Witness has not verified this footage.

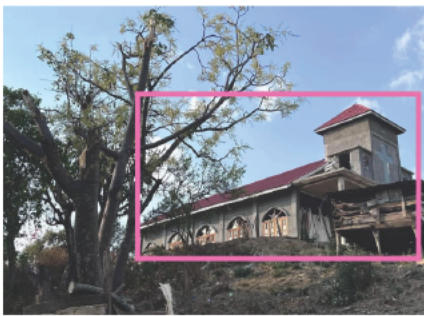
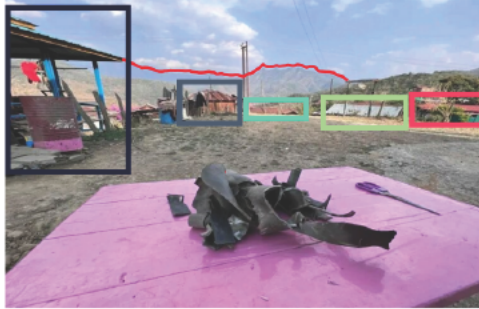
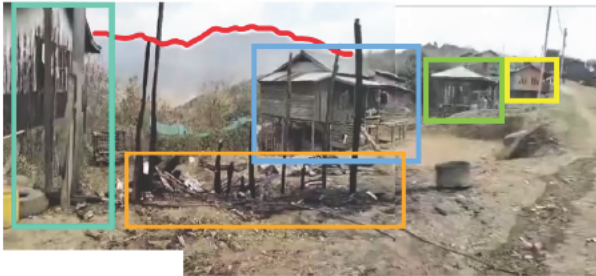
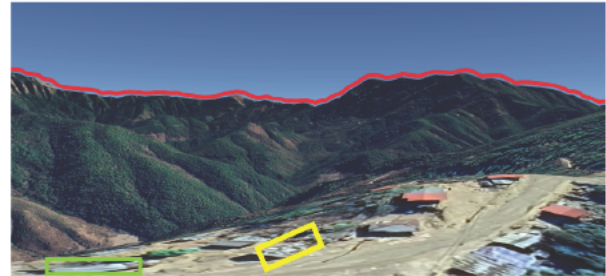
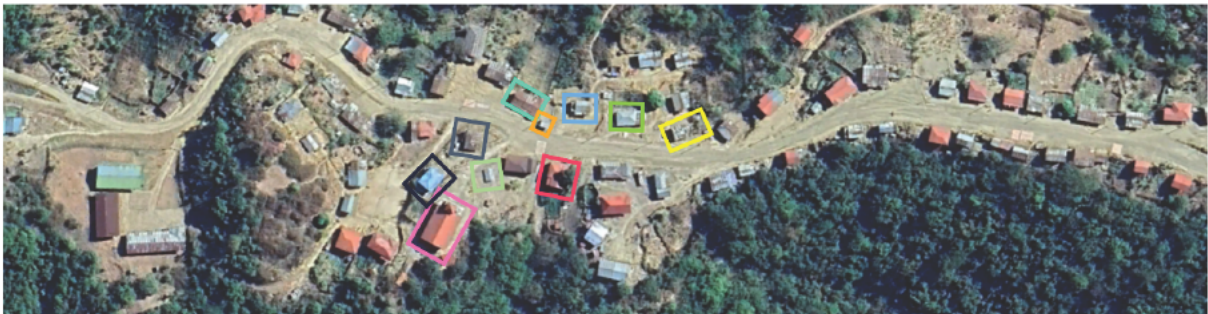
MAF AIRSTRIKES ON KHUAFO VILLAGE ALLEGEDLY RESULTED IN THE DESTRUCTION OF RESIDENTIAL AND CHURCH BUILDINGS AS WELL AS 8 CIVILIAN CASUALTIES. MYANMAR WITNESS HAS GEOLOCATED FOOTAGE WHICH SHOWS DAMAGE TO THE WINDOWS OF KHUAFO BAPTIST CHURCH, SHOWN HERE IN THE PINK BOX.

FOOTAGE APPEARS TO SHOW DEBRIS FROM AN 80MM S-8 UNGUIDED AIR-TO-GROUND ROCKET, CONSISTENT WITH CLAIMS OF AN AIRSTRIKE.

Figure 7: Infographic created by Myanmar Witness including geolocated UGC which purports to show the aftermath of an airstrike in Khuafo [22.751744, 93.425397] (sources: [Khonumthung Burmese](#), warning: graphic link; [Vafim Thuro](#); [The Chin Post](#)).

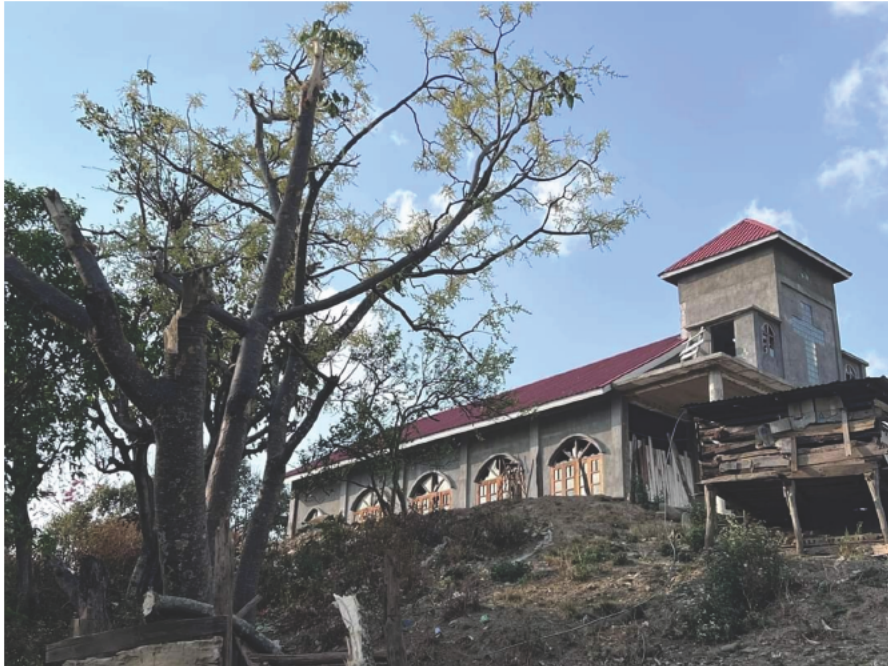
Figure 8: It is alleged that Kuafo Baptist Church was damaged following airstrikes on 30 March. UGC shared on the day appears to show smashed windows [22.751632, 93.425222] (source: [Khonumthung Burmese](#), warning: graphic link).

Local media [shared](#) (warning: graphic link) extensive footage reportedly showing the aftermath of MAF airstrikes in Kuafo. Images shared by [Khonumthung Burmese](#) (warning: graphic link) on the day of the alleged airstrike, appear to show minor damage to the exterior of Kuafo Baptist Church (see Figure 8 below). Myanmar Witness has geolocated UGC, which shows smashed windows on the south-facing side of the building. Investigators were unable to verify that this damage was sustained as a result of the alleged airstrike.

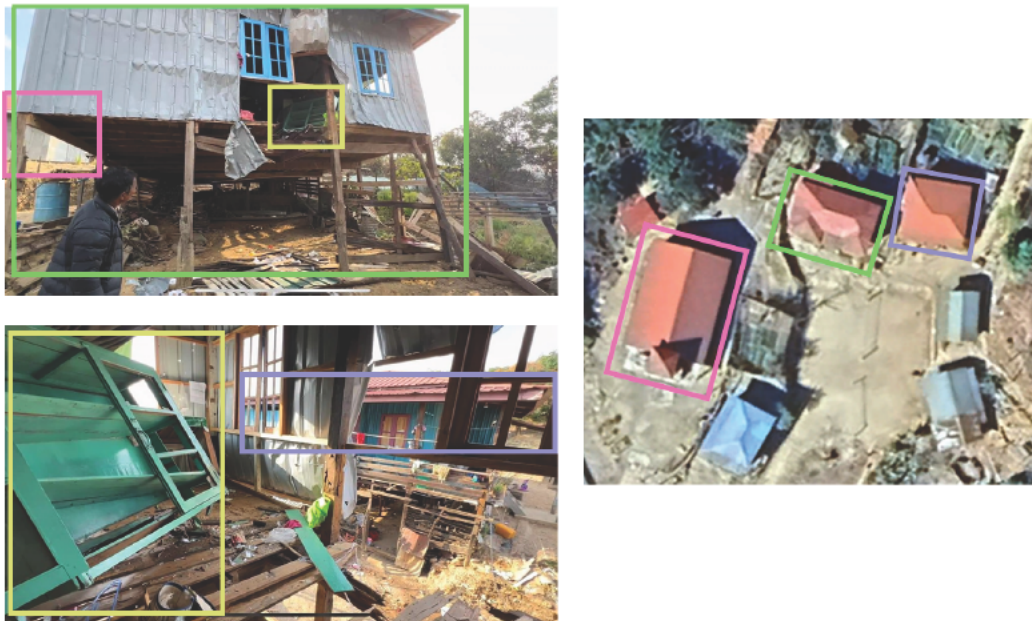
Figure 9: Myanmar Witness has geolocated footage showing significant damage to the residential buildings which neighbour Khuafu Baptist Church, shown here in the pink box [22.752130, 93.425063] (source: [Ayeeyarwaddy Times](#), warning: graphic link).

Myanmar Witness has also analysed images showing considerable damage to residential buildings in the village. UGC shows structural damage to buildings near the Kuafo Baptist Church. One house appears to have a large hole in its exterior wall and significant damage to the interior (see Figure 9 on the following page). Myanmar Witness was unable to verify that this damage was sustained due to an airstrike. However, the extent of structural damage suggests that a weapon of considerable power was responsible.

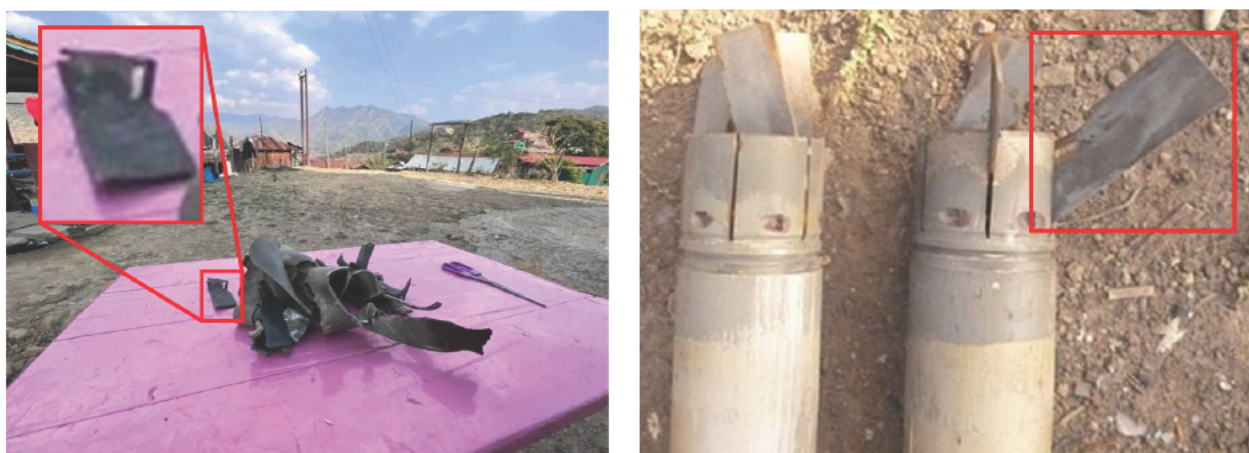
Figure 10: Visual comparison of remnants from Khuafu (left) to confirmed S-8-type rockets' fins sections (right) (sources: [The Chin Journal](#); [Myanmar Witness](#)).

Myanmar Witness has analysed [UGC](#), allegedly showing debris recovered after the reported airstrike. The crumpled metalwork is consistent with damage sustained by a long rocket upon impact. Munitions analysis identified parts of the fin section from an S-8 80mm unguided rocket (see Figure 10 below). However, Myanmar Witness was unable to verify that the debris originated from the same weapon. The footage was geolocated and shows wreckage arranged on a pink tray in front of Khuafu Baptist Church (see Figure 11 on the following page). Since S-8 rockets are exclusively air-launched, the apparent presence of debris is consistent with the allegation of an airstrike. Given its proximity to a known place of worship, this UGC sustains the allegation that the conflict has impacted churches.

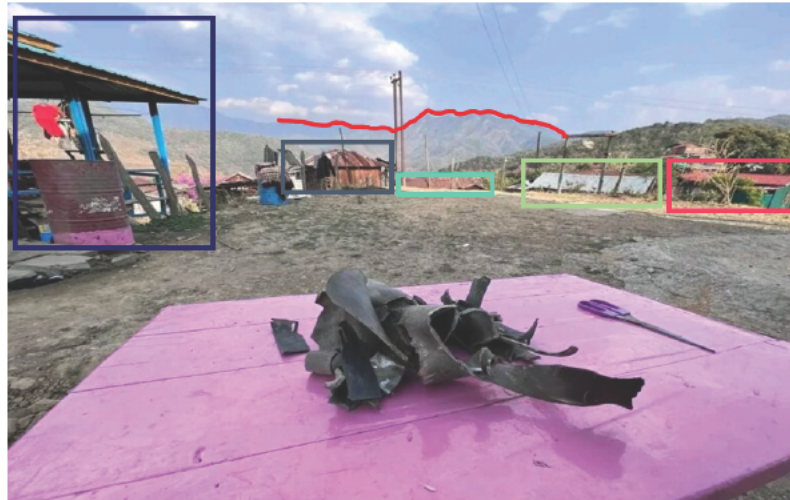
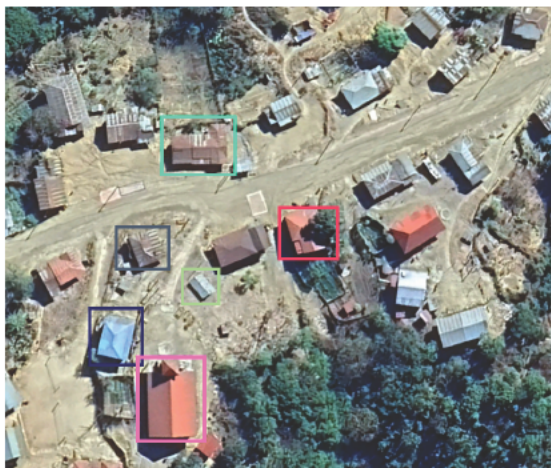
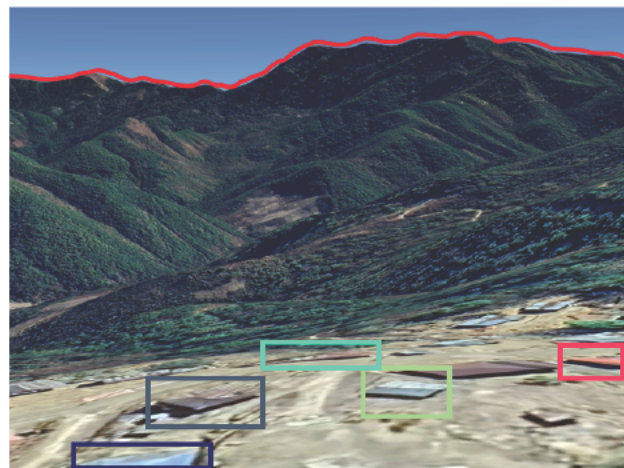
Figure 11: Geolocation of UGC reportedly showing debris from an S-8-type rocket in front of the Khuafu Baptist Church (shown in the pink box) [22.751822, 93.425291] (sources: [The Chin Journal](#); [Myanmar Witness](#)).

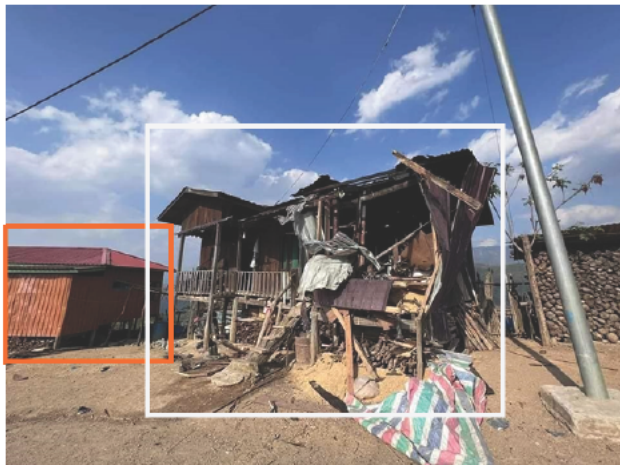
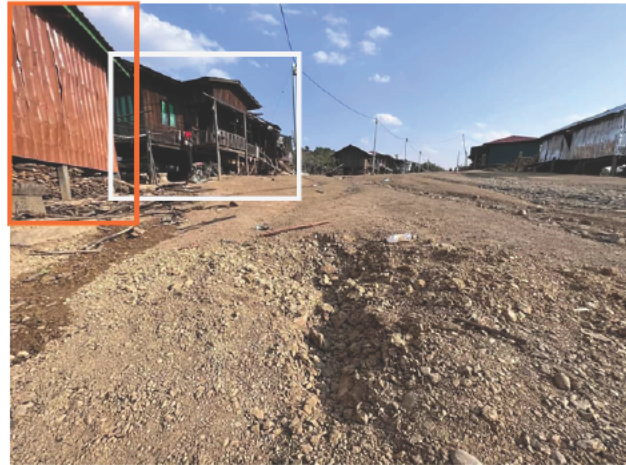
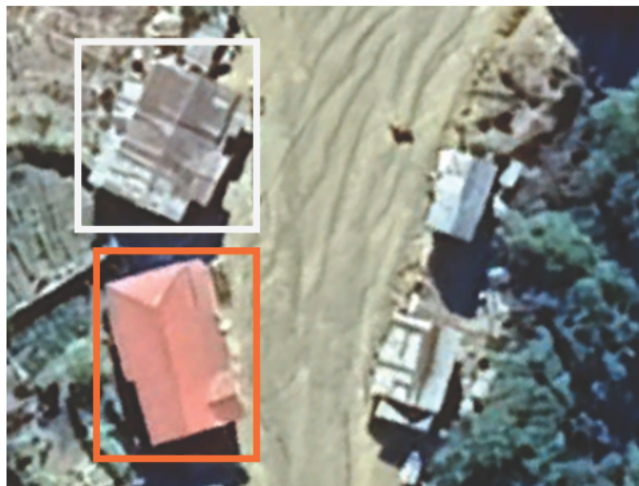
Figure 12: Geolocation of UGC reportedly showing a crater nearby destroyed residential houses [22.750288, 93.425819] (source: personal Facebook account, redacted due to privacy concerns).

The destruction of additional residential buildings is demonstrated in further UGC. Footage shows sizable craters near houses, which appear to have sustained extensive structural damage (see Figure 12 on the following page). Though Myanmar Witness cannot verify that the destruction of residential property is linked to the alleged airstrike, the presence of craters supports the allegation that powerful explosive weapons were the likely cause of damage in the village.

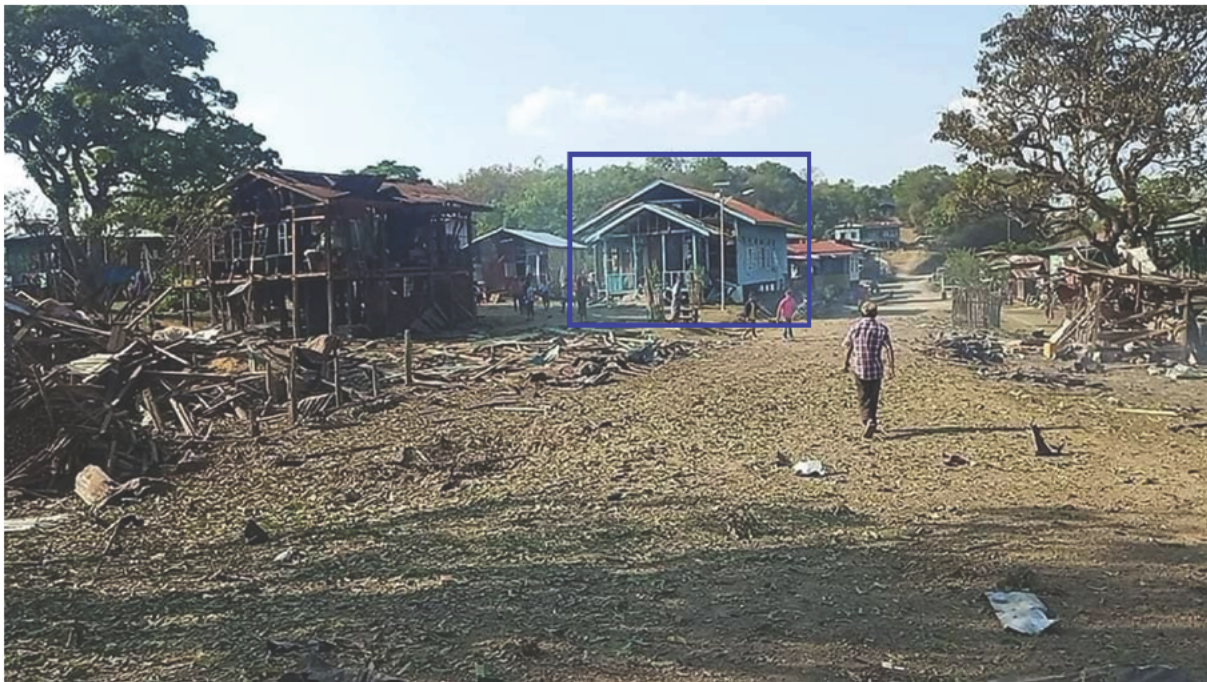
Figure 13: Myanmar Witness geolocated UGC showing damage to buildings in Tlanglo Village, including the Presbyterian Church of Myanmar, shown here in the navy box [23.008634, 93.337030] (source: [Presbyterian Church of Myanmar - General Assembly](#)).

Myanmar Witness has geolocated UGC, which appears to show significant structural damage to the Presbyterian Church of Myanmar and surrounding houses (see Figure 13 below). Since the footage cannot be chronolocated due to a lack of clear satellite imagery, Myanmar Witness was unable to verify when the attack occurred, though the UGC analysed in the following pages was all shared on or shortly after the claimed date.

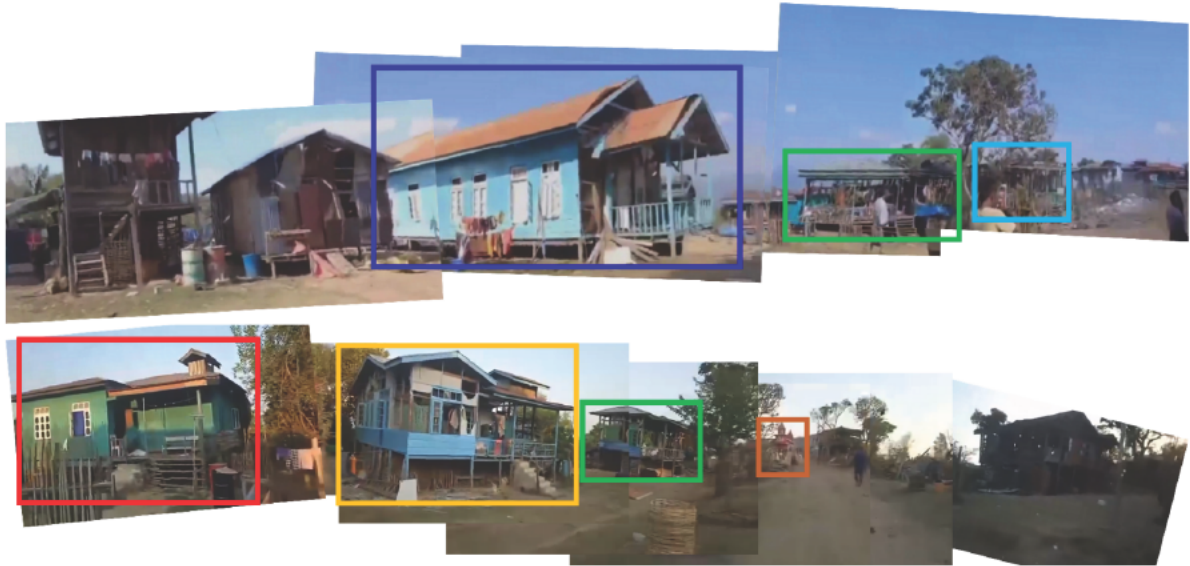
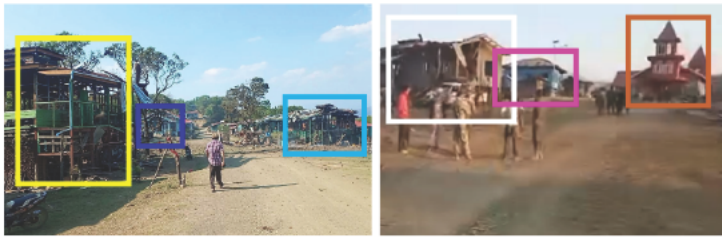
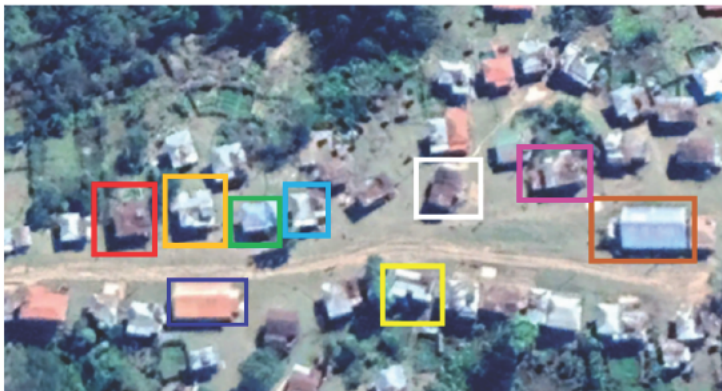
MAF AIRSTRIKES REPORTEDLY RESULTED IN THE DESTRUCTION OF 3 CHURCHES AND AROUND 30 HOUSES IN TLANGLO. IT IS ALLEGED THAT 2 CIVILIANS WERE KILLED. MYANMAR WITNESS GEOLOCATED FOOTAGE SHOWING DAMAGE TO THE PRESBYTERIAN CHURCH OF MYANMAR, SHOWN HERE IN THE NAVY BOX.

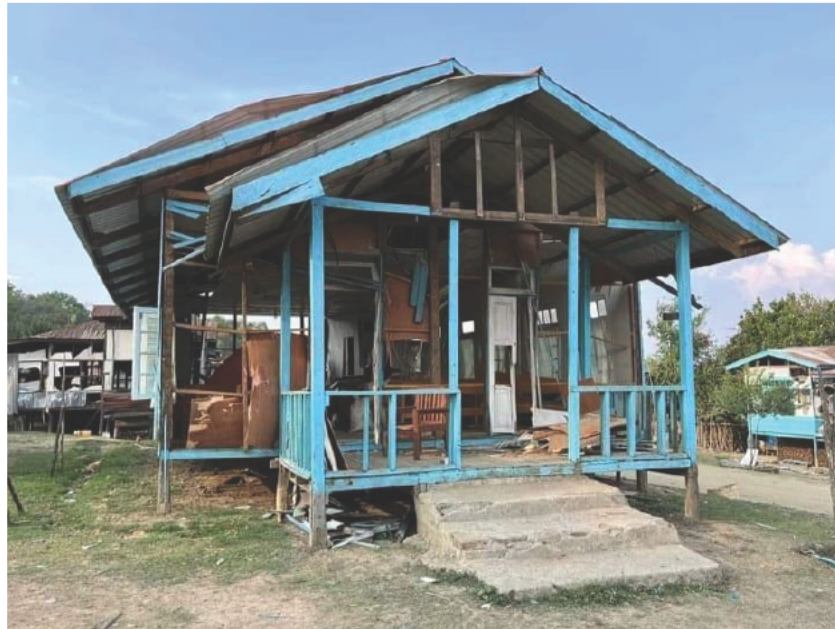
Figure 15: UGC shows damage apparently sustained to the Tlanglo branch of the Presbyterian Church of Myanmar following the alleged airstrike on the village [23.009121, 93.337024] (sources: [The Chin Journal](#); [Presbyterian Church of Myanmar - General Assembly](#)).

UGC shows extensive structural damage to the front of the church. The south-facing wall appears to have been destroyed, while the corrugated roof shows signs of warping. One photo, shared by the [Presbyterian Church of Myanmar General Assembly](#), offers a view inside the church through the destroyed front wall (see Figure 15 below). This image appears to show significant damage to the interior of the building, while the rear wall also appears to have been destroyed.

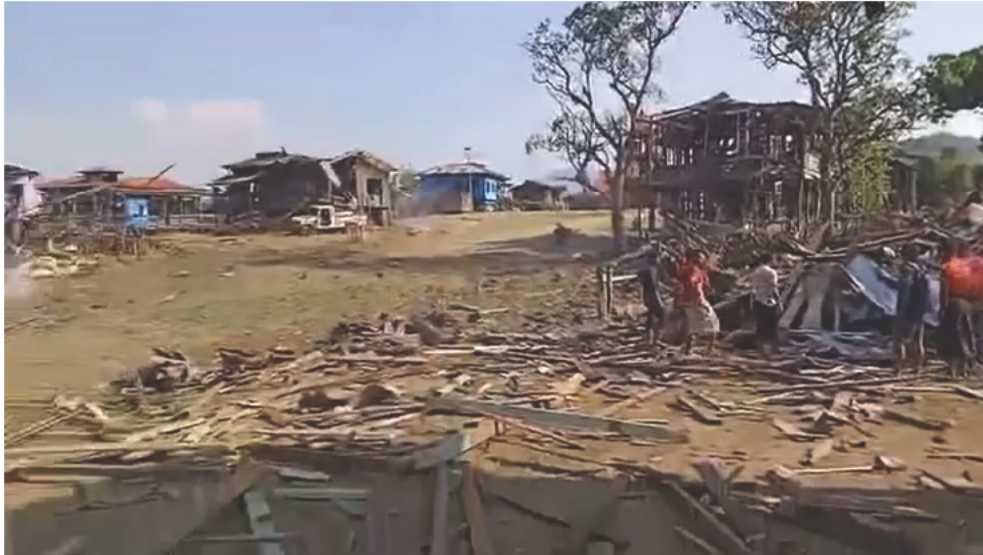
Figure 16: UGC appears to show a large pile of rubble apparently resulting from the bombing of residential buildings [23.008992, 93.337001] (source: [Chindwin News Agency](#)).

Myanmar Witness also verified damage to residential buildings in Tlanglo. UGC appears to show large piles of timber and rubble, allegedly resulting from the destruction of houses (see Figure 16 below).

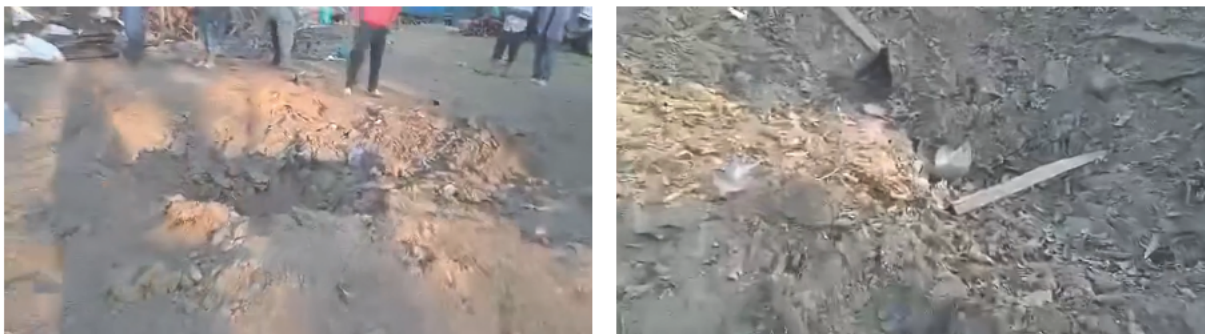
Figure 17: Footage appears to show 2 large craters in the middle of the main road running through Tlanglo village (source: [Global Tlanglo Youth Organization - GTYO](#)).

Video footage [shared](#) on the day of the reported airstrike appears to show two sizable craters in the middle of the main road through the village (see Figure 17 below). Myanmar Witness was not able to verify the occurrence of an airstrike on 27 April due to a lack of UGC showing aircraft in the vicinity. However, given the presence of craters and the extent of structural damage visible across Tlanglo, an aerial bombardment is a likely cause.

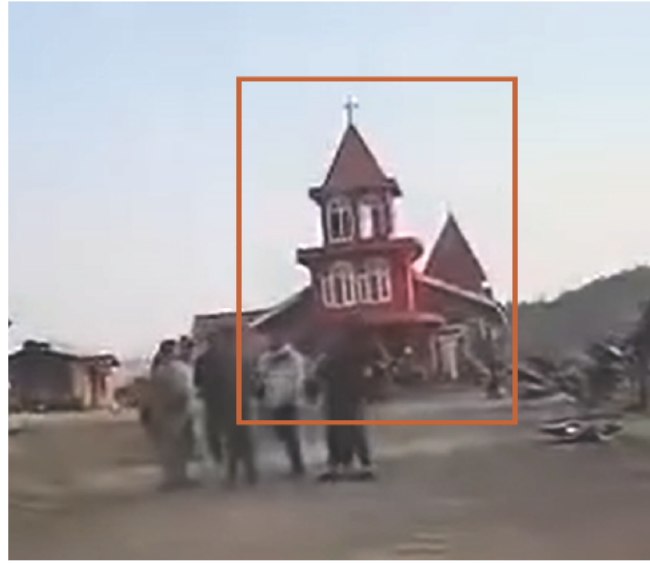
Figure 18: Tlanglo Baptist Church (shown here in the brown box) is visible in UGC shared on the day of the alleged airstrike. Owing to the low resolution of this footage, Myanmar Witness was unable to verify damage to the church building [23.008091, 93.336918] (source: [Global Tlanglo Youth Organization - GTYO](#)).

Though the Presbyterian Church of Myanmar was the only religious building where damage was verified in Tlanglo village, it was [alleged](#) that two other places of worship within the village were also damaged. Myanmar Witness used Google Maps data combined with the UGC to identify Tlanglo Baptist Church (see Figure 18 on the following page). However, Myanmar Witness was unable to verify damage to this structure.

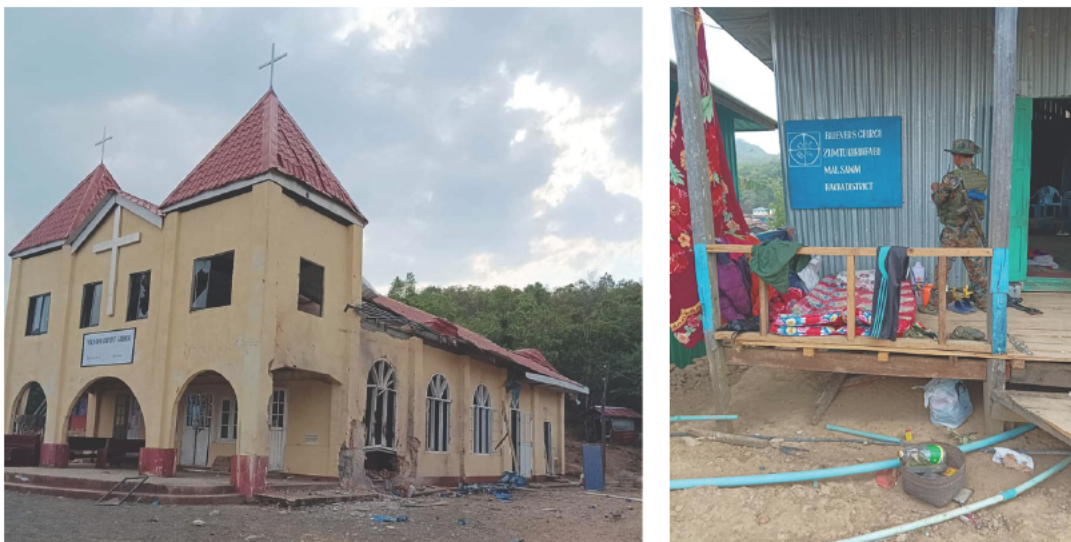
Figure 19: Footage shared by The Chin Journal shows extensive damage to Malsawm Baptist Church (left), which can be identified by the sign above its main entrance. Additional UGC shows the aftermath of the alleged military occupation of Believers Church Malsawm (right) (source: [The Chin Journal](#); personal Facebook account, redacted due to privacy concerns).

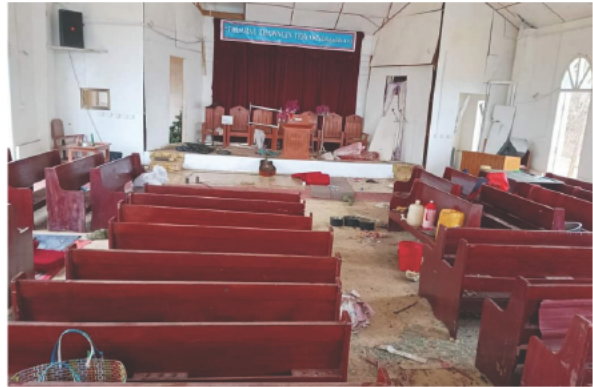
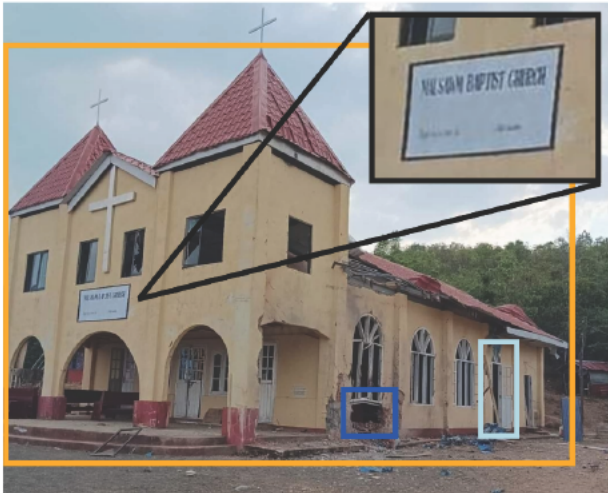
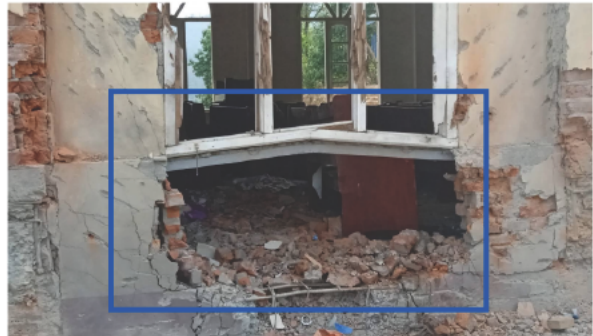
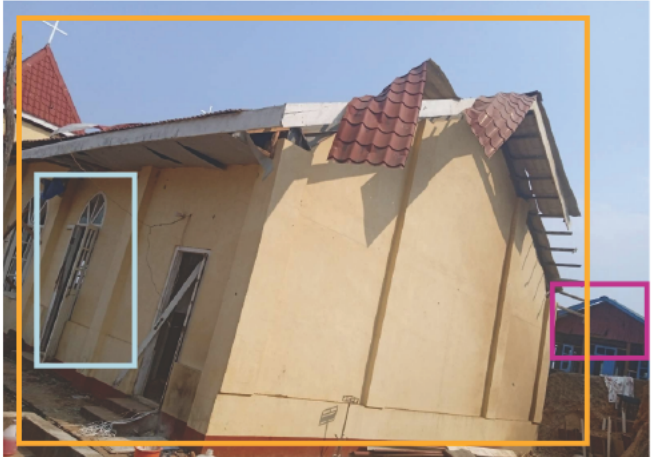
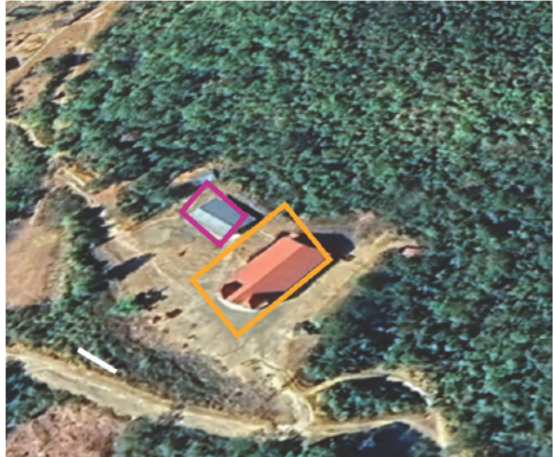
Figure 20: Graphic of geolocated UGC from Malsawm Baptist Church [22.515474, 93.781116] (sources: [Chin Human Rights Organization](#); [The Chin Journal](#)).

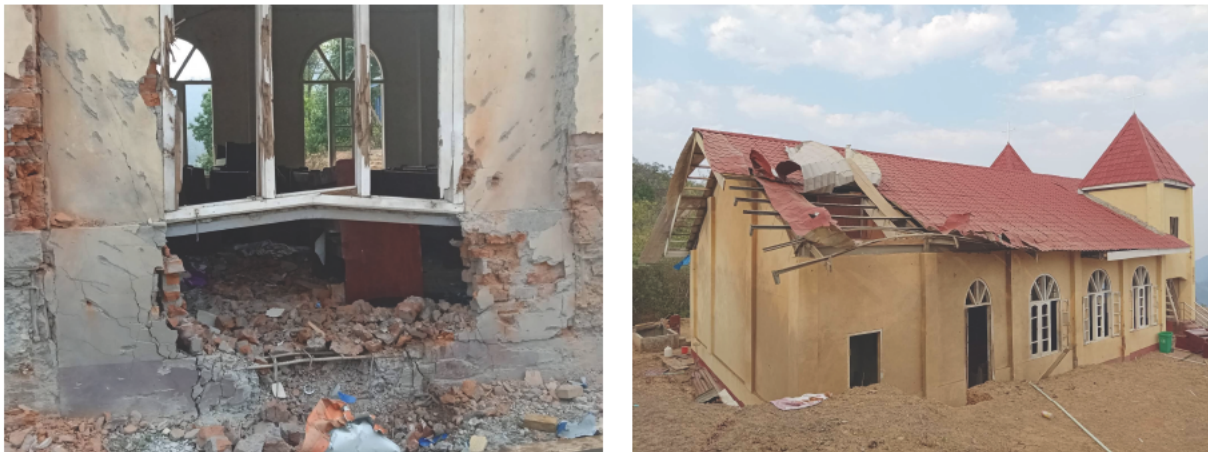
Figure 21: Geolocated UGC showing structural damage to the exterior wall and roof of Malsawm Baptist Church (sources: [Chin Human Rights Organization](#); personal Facebook account, redacted due to privacy concerns).

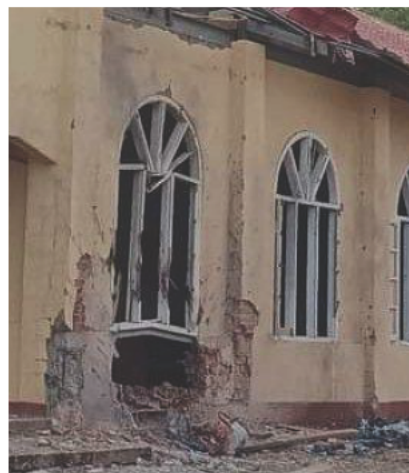
Figure 22: Footage appears to show burn marks around the damaged window of Malsawm Baptist Church (source: [The Chin Journal](#)).

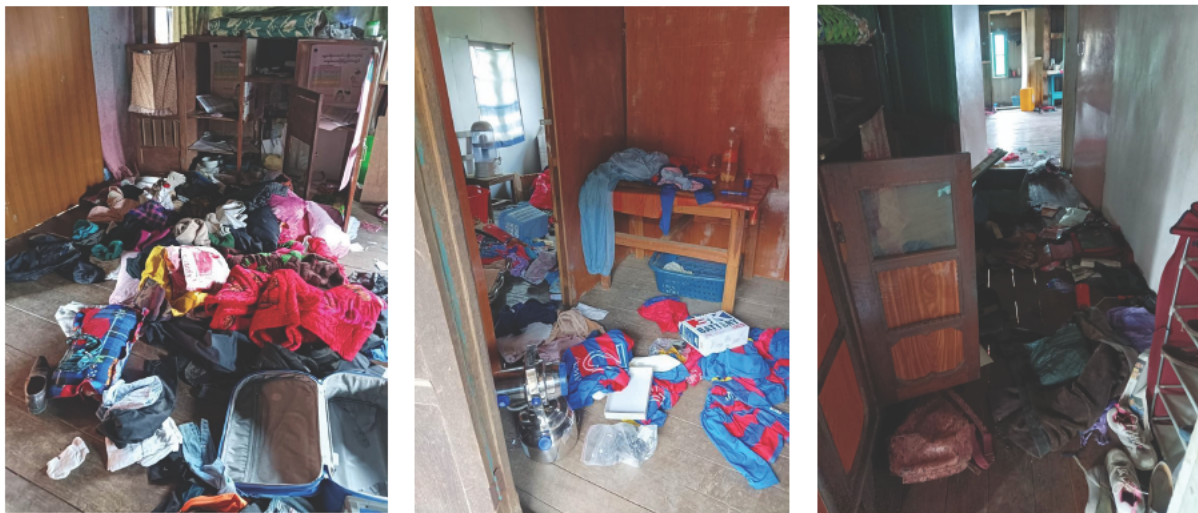
Figure 23: It is alleged that these images show the aftermath of the SAC occupation of Malsawm. Myanmar Witness has not been able to verify the claim that soldiers ransacked buildings in the village (source: personal Facebook account, redacted due to privacy concerns).

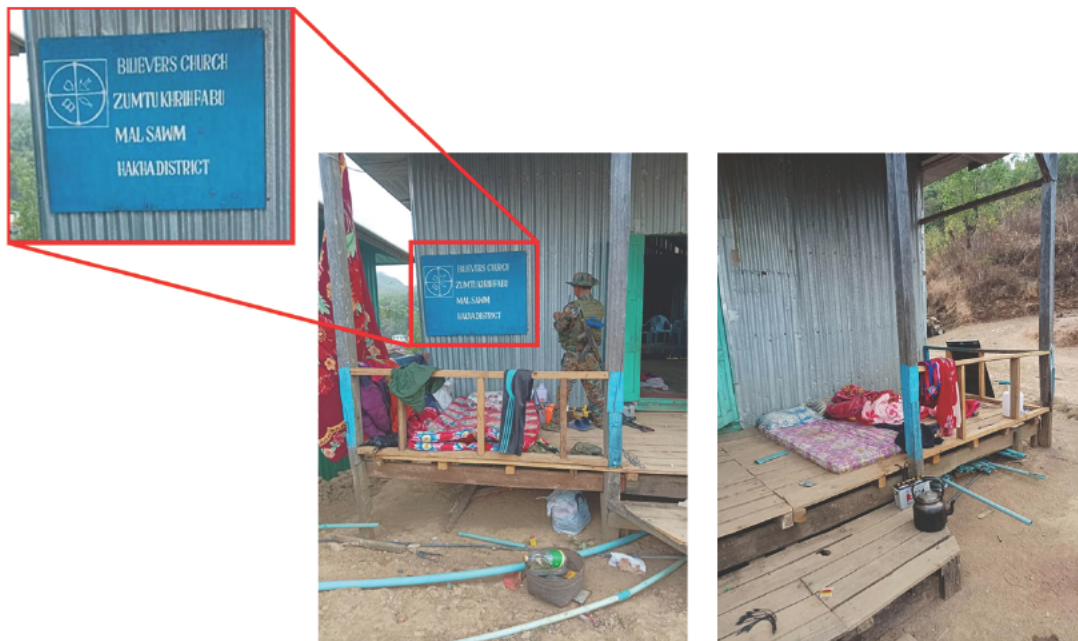
Figure 24: Geolocated UGC allegedly showing the impact of military presence in Believers Church Malsawm. Myanmar Witness has been unable to verify the allegiance of the soldier visible in the left-hand image (source: personal Facebook account, redacted due to privacy concerns).

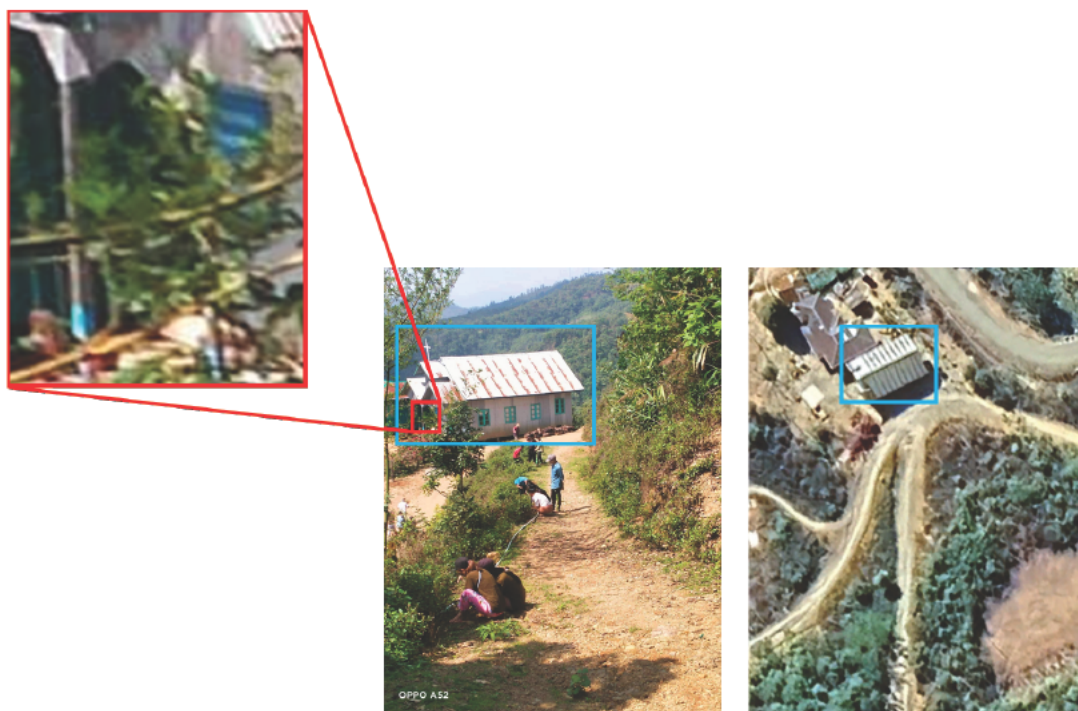
Figure 25: A reference photo shared in May 2022 allowed investigators to geolocate the UGC showing Believers Church Malsawm. The blue sign and distinctive painted poles are visible. Features such as the cross above the

entrance identify the structure as a Christian church [22.514909, 93.781262] (source: personal Facebook account, redacted due to privacy concerns).

[The Chin Journal](#) claimed that in addition to Malsawm Baptist Church, troops from LID 77 occupied and ransacked Believers Church. Myanmar Witness analysed images shared by a personal Facebook account on 11 May, which depict Believers Church Malsawm [22.514620, 93.781223] (see Figure 24 on the following page). The source of these images has been redacted due to privacy concerns. Using earlier imagery shared by the same account, it was possible to identify and geolocate distinctive features such as the blue sign and painted support poles (see Figure 25 on the following page).

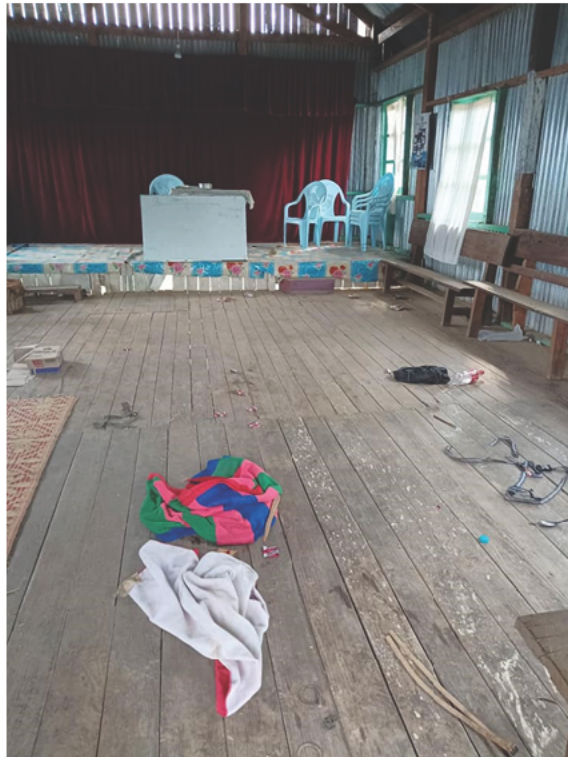
Figure 26: After the alleged military presence in Believers Church Malsawm, footage was shared of the interior. Myanmar Witness was unable to verify that the scattered objects visible in this imagery were linked to claims of looting or SAC occupation (source: personal Facebook account, redacted due to privacy concerns).

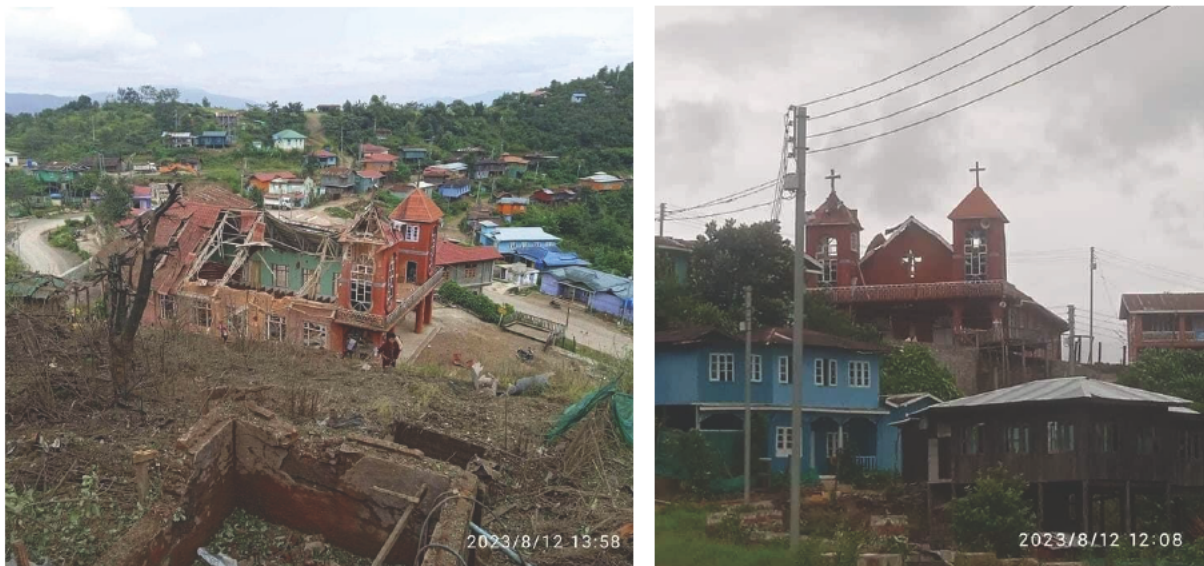
Figure 27: Timestamped UGC shows extensive structural damage to Ramthlo Baptist Church (sources: [Burma Media Consortium](#); [The Chin Journal](#), warning: graphic link).

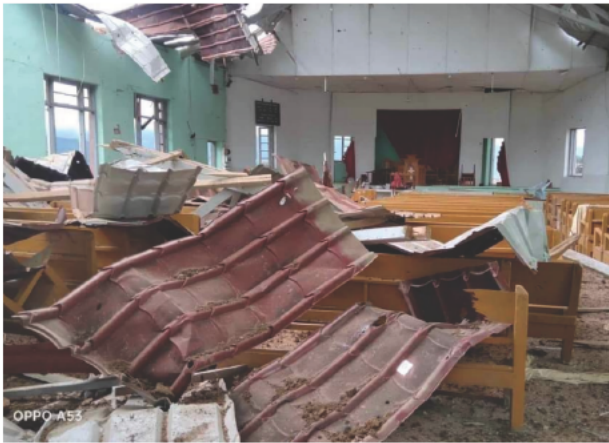
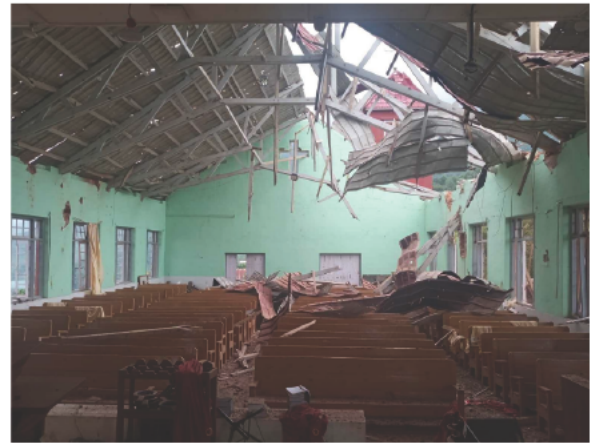
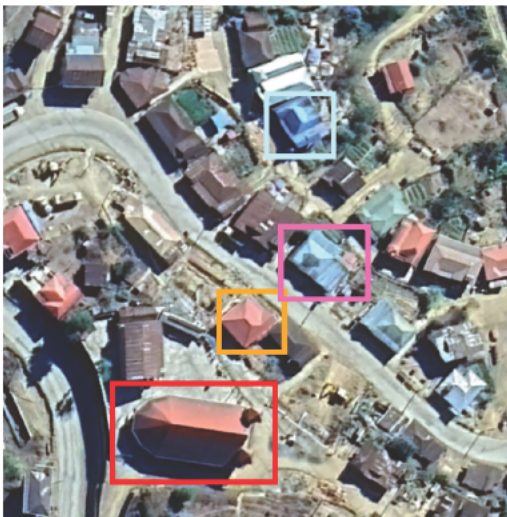
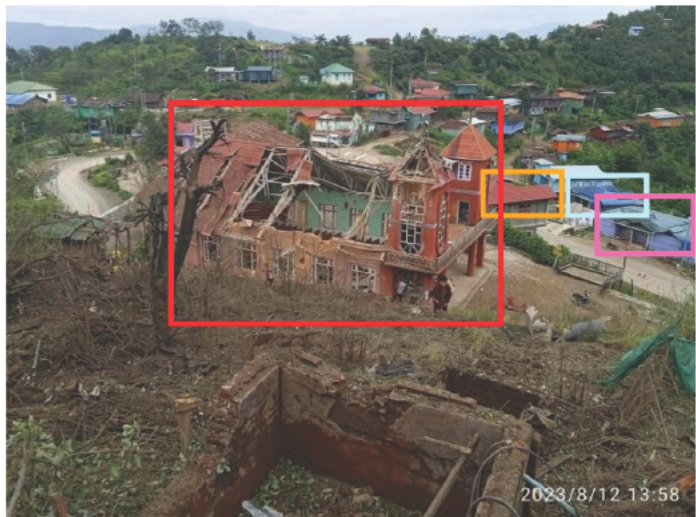
Figure 28: Graphic showing UGC which has been geolocated by Myanmar Witness to Ramthlo Baptist Church [22.826175, 93.561084] (source: [Burma Media Consortium](#); [Chin Human Rights Organization](#); personal Facebook account, redacted due to privacy concerns).

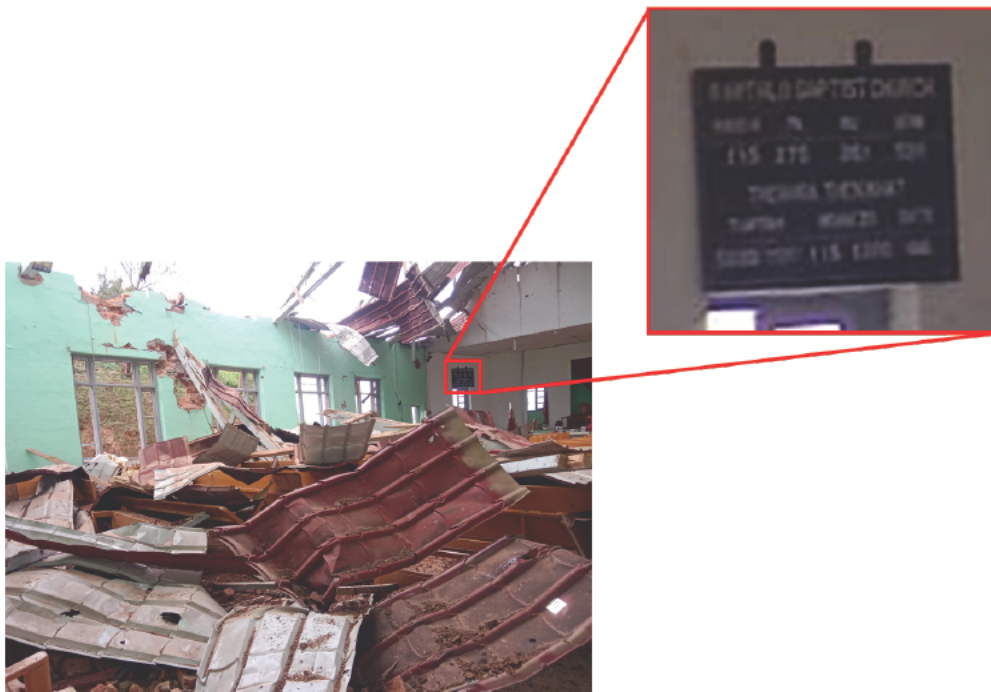
Figure 29: Signage visible in UGC identifies the building as Ramthlo Baptist Church. Debris appears to have fallen from the roof, damaging church pews and other property (source: personal Facebook account, redacted due to privacy concerns).

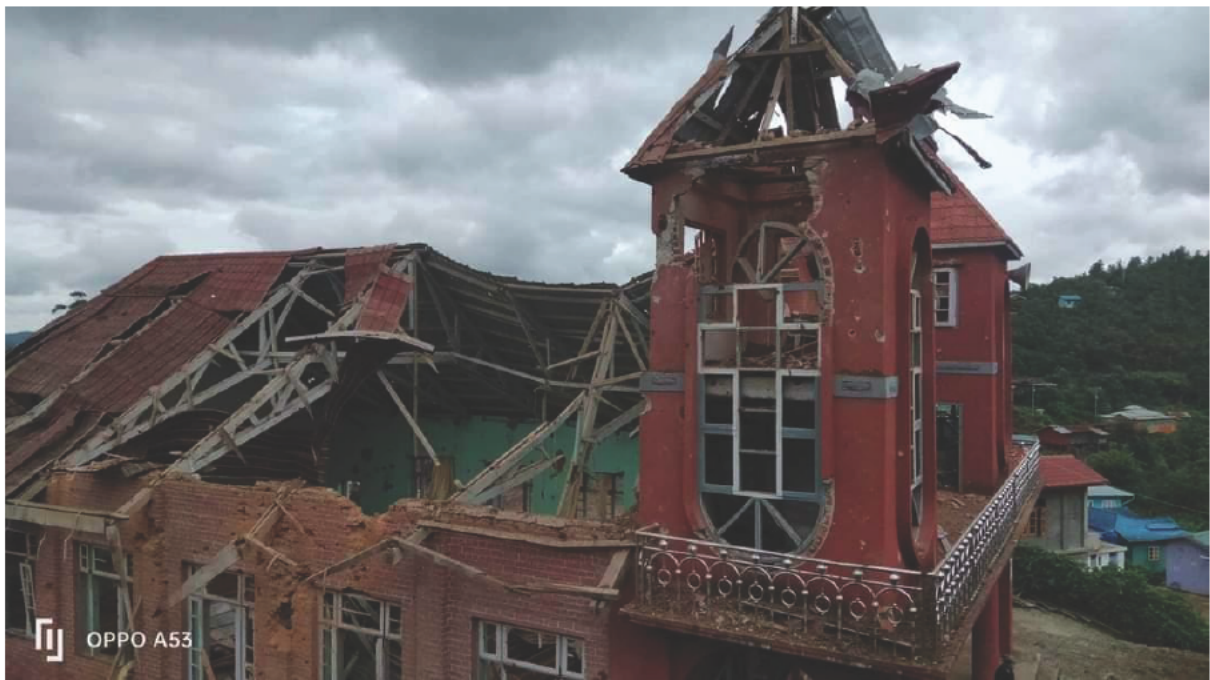
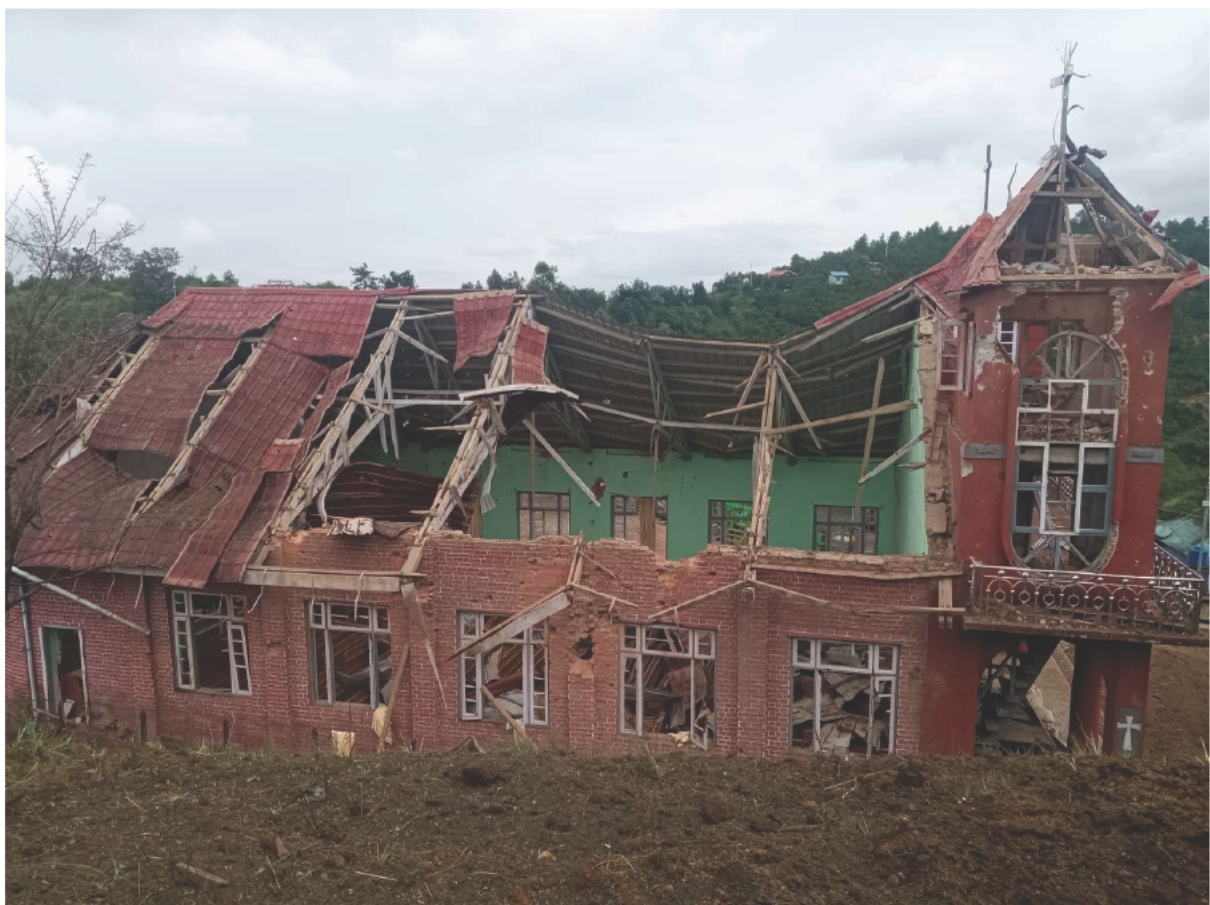
Figure 30: Footage shows a large hole in the roof of the church, in addition to structural damage to the towers and brickwork (sources: [The Chin Journal](#), warning: graphic link; personal Facebook account, redacted due to privacy concerns).

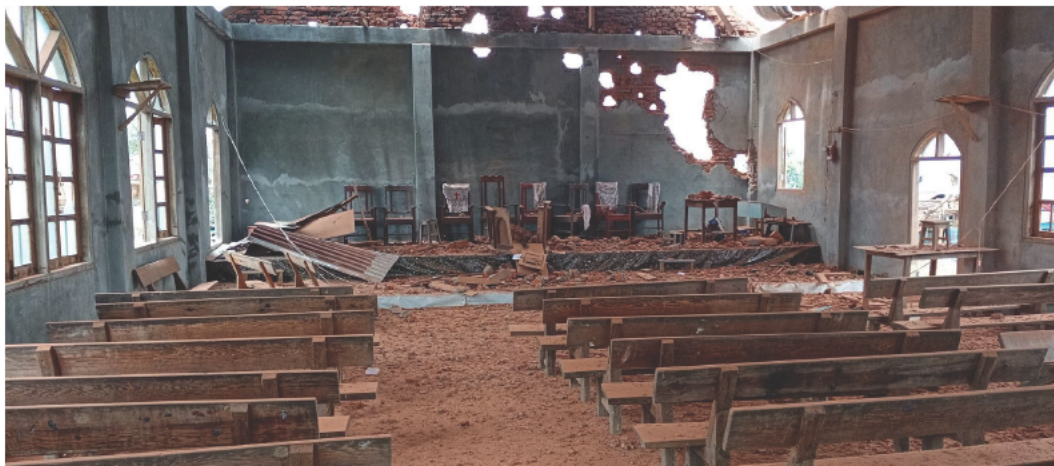
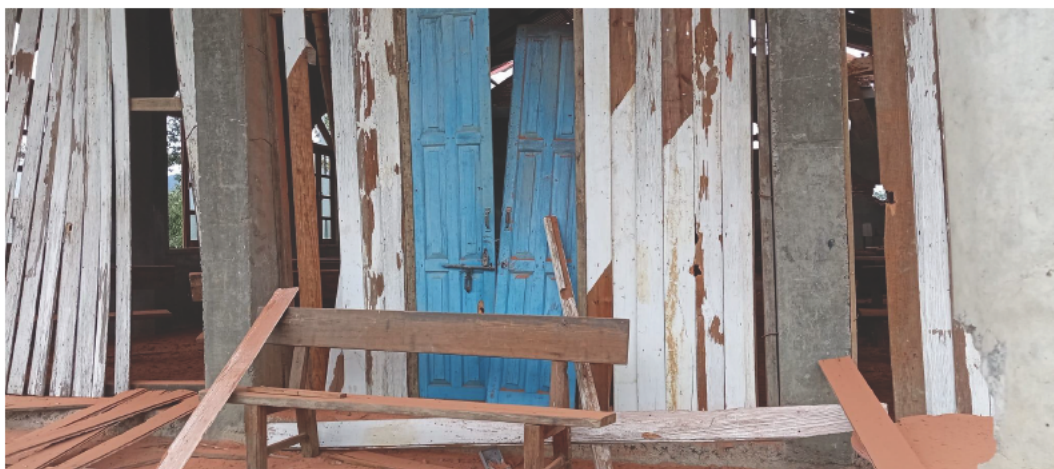
Figure 31: Imagery from the claimed airstrike on Khuafo. Damage to the interior of Khuafo Baptist Church (top), along with damage to the front door and walls of the church (bottom) (source: [Khit Thit Media](#)).
