Conflict-stricken Churches

The impact of the conflict on church buildings across Chin state

REPORT BY MYANMAR WITNESS, published January 2024, information accurate as of July 2023

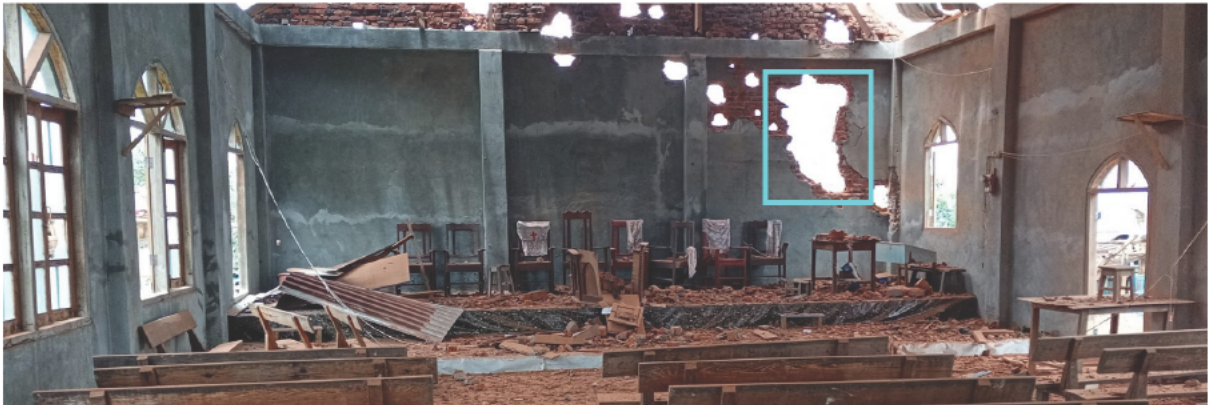
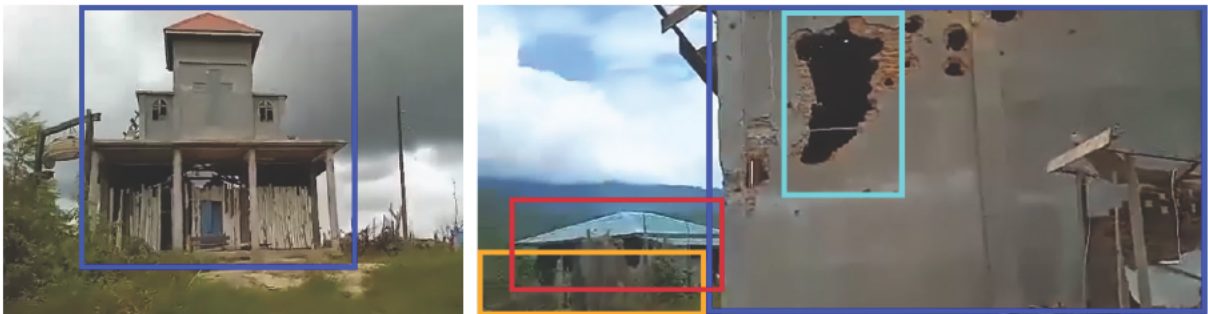
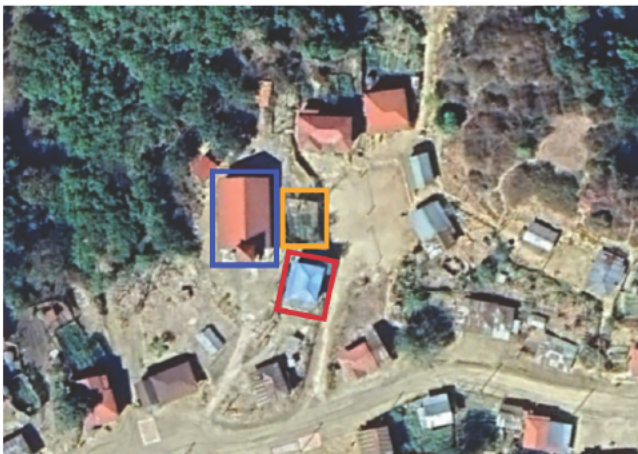
THE MAF ALLEGEDLY CONDUCTED AN AIRSTRIKE ON KHUAFO VILLAGE WHICH RESULTED IN THE DESTRUCTION OF A LOCAL BAPTIST CHURCH AND 4 RESIDENTIAL BUILDINGS. FOOTAGE GEOLOCATED BY MYANMAR WITNESS SHOWS EXTENSIVE DAMAGE TO THE INTERIOR AND EXTERIOR OF THE CHURCH, SHOWN HERE IN THE NAVY BOX.

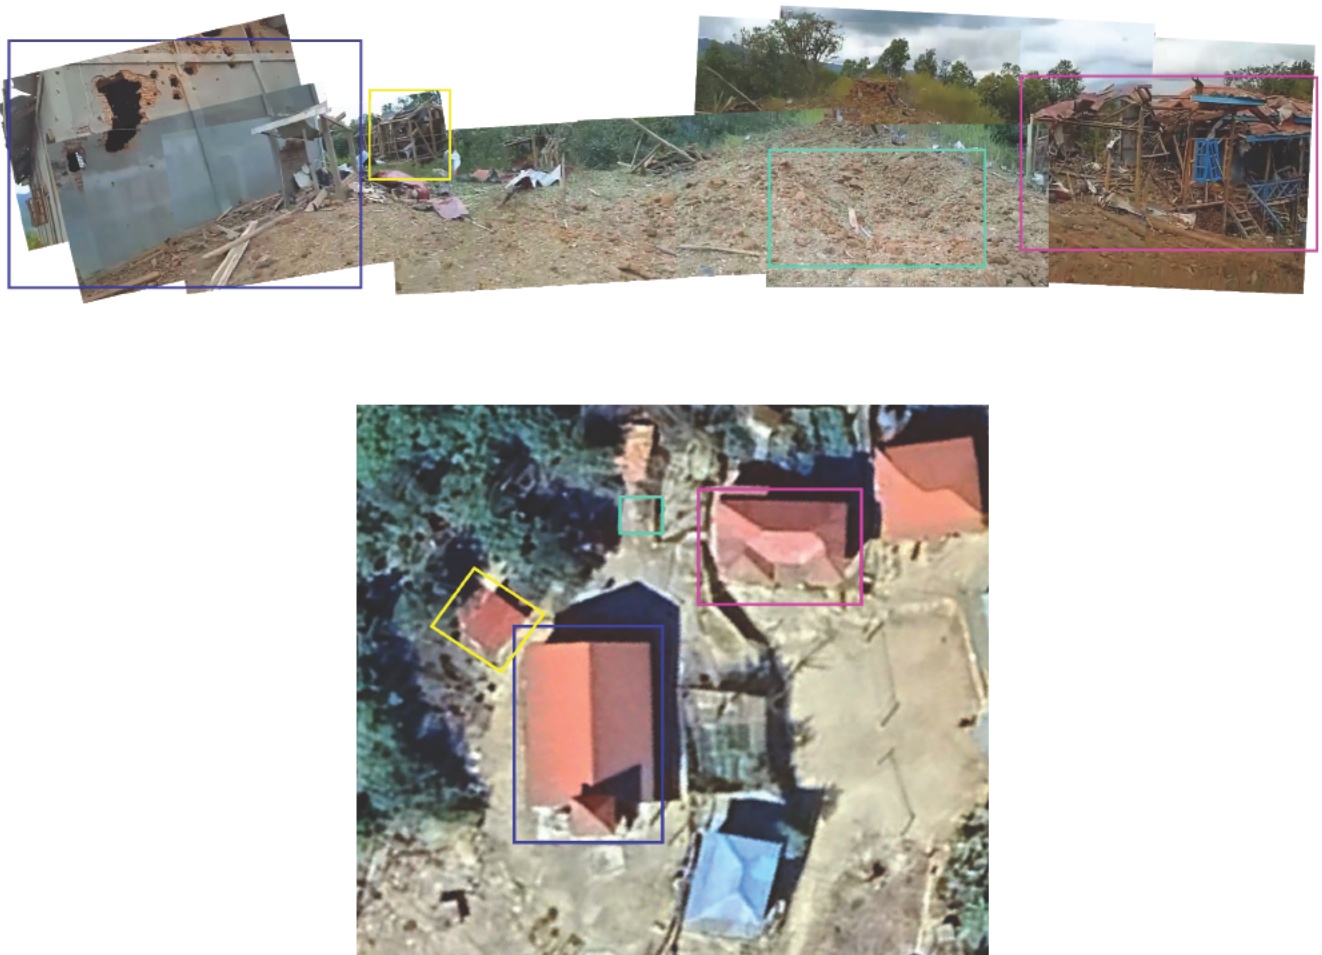
Figure 33: A video shared on the day of the alleged airstrike shows a large crater between Khuafu Baptist Church and a nearby residential building. Myanmar Witness created a panorama from this footage, which shows structural damage to both buildings. The video was then geolocated using satellite imagery from Google Earth (source: [The Independent Post](#)).

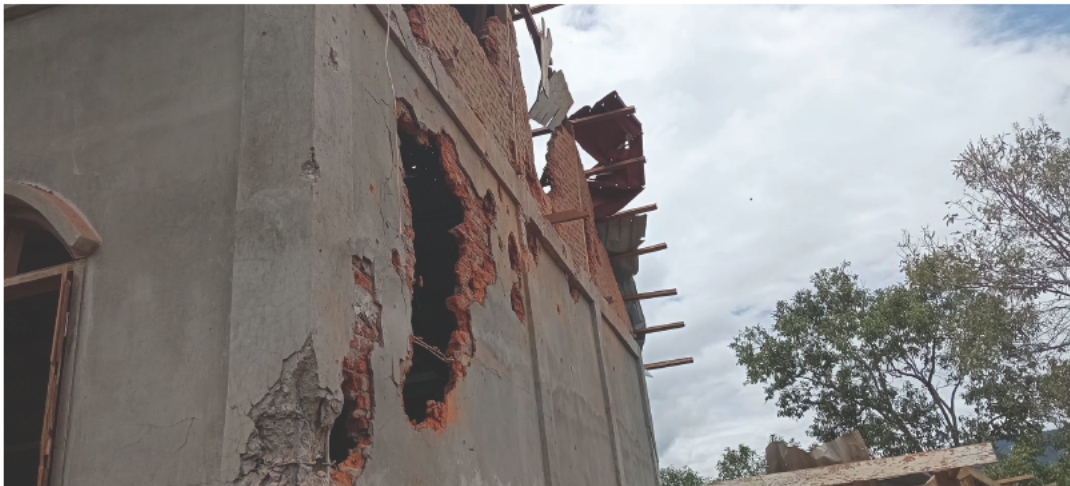
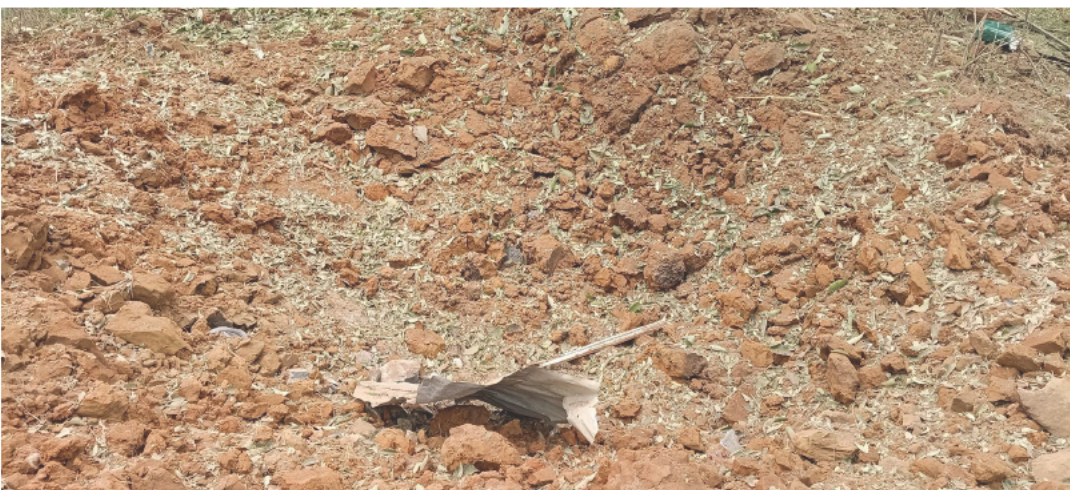
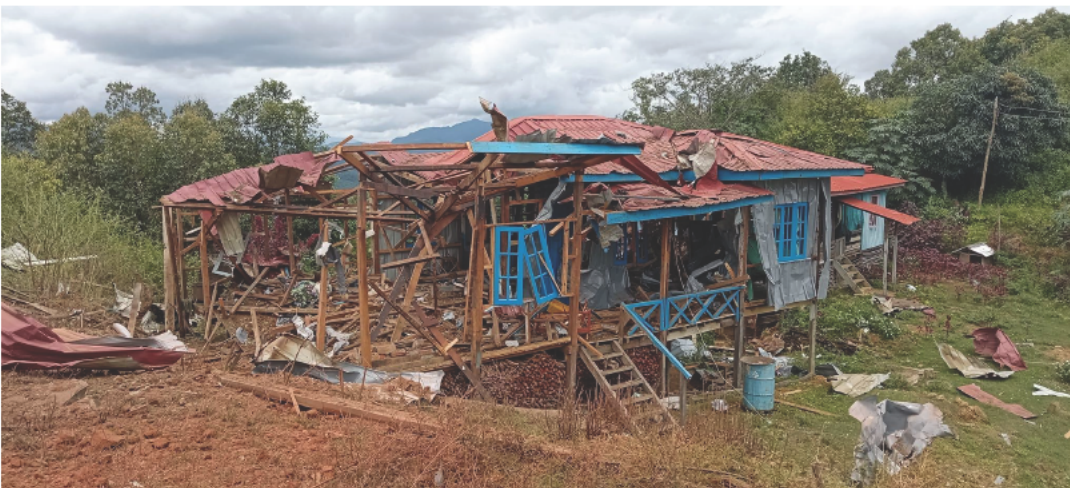
Figure 34: Images shared on the day of the alleged airstrike appear to show structural damage to the rear of Kuafo Baptist Church (top), a large crater in the ground behind the church (middle) and a destroyed residential building (bottom). This footage has been compared with a [video](#) also claiming to show the aftermath of the incident (see Figure 33) and has been geolocated by Myanmar Witness (source: [Khit Thit Media](#)).

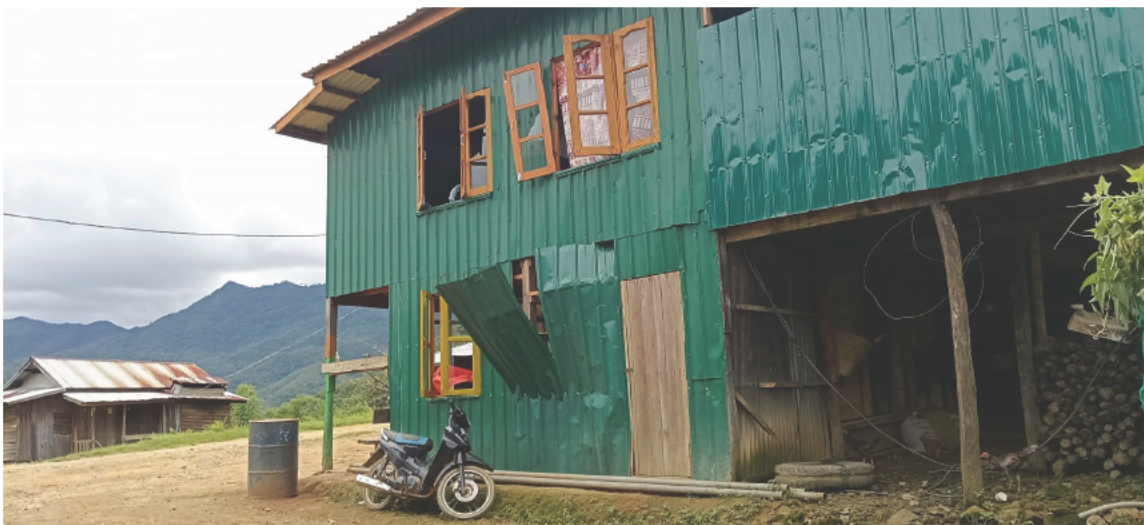
Figure 35: UGC showing damage to a residential building in Khuafu, [geolocated](#) by Myanmar Witness [22.751454, 93.425418] (source: [Khit Thit Media](#)).

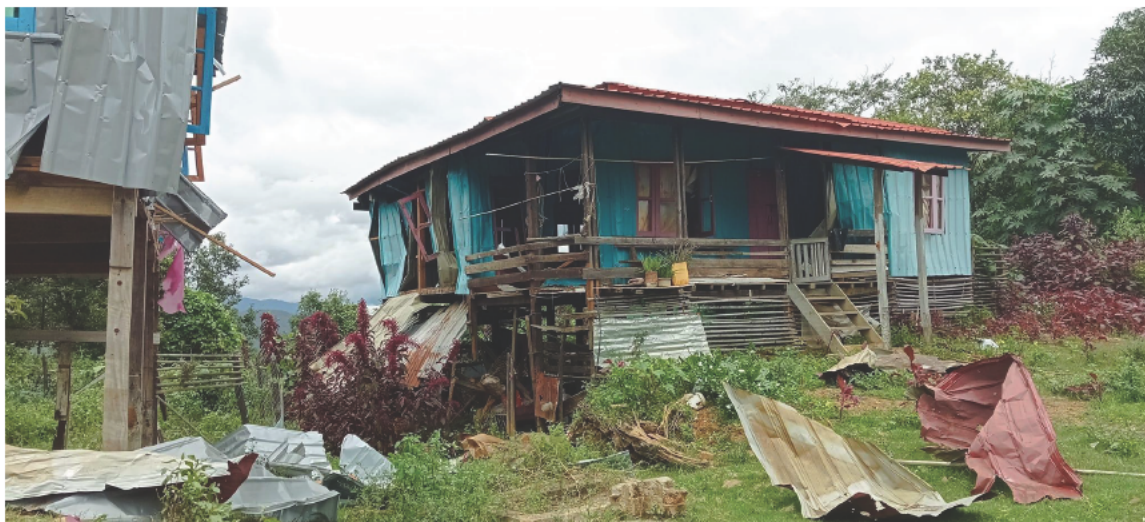
Figure 36: UGC showing damage to a residential building in Khuafu, geolocated by Myanmar Witness [22.752099, 93.425127] (source: [Khit Thit Media](#)).

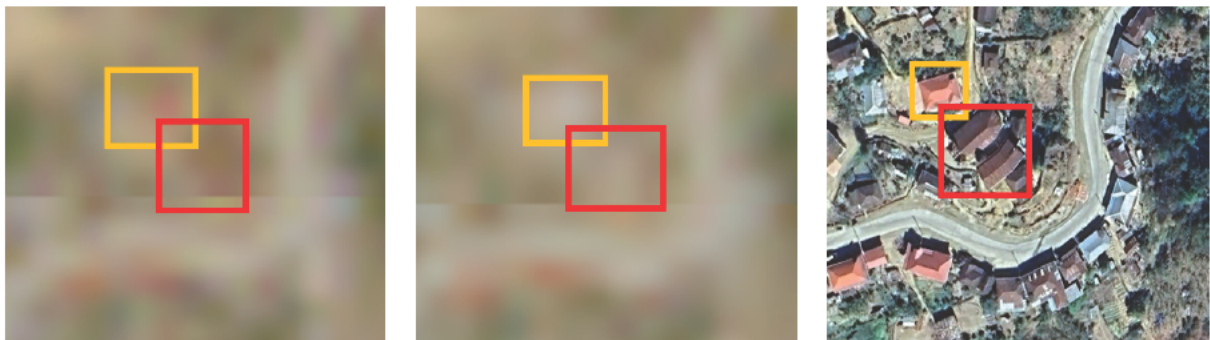
Figure 37: Satellite imagery from 23 April (left) was compared with imagery from 8 May (right). Analysis revealed possible damage to buildings with church-like characteristics during this timeframe [22.769635, 93.568785].
